WRIGHT GROUP INC.

Scott Blake

250 Edwards Boulevard
Lake Geneva, WI

INTRODUCTION:

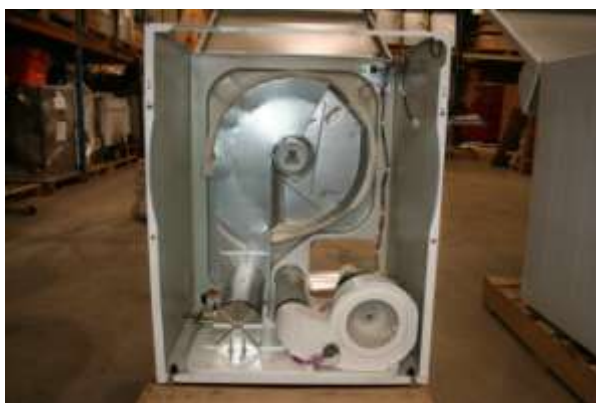
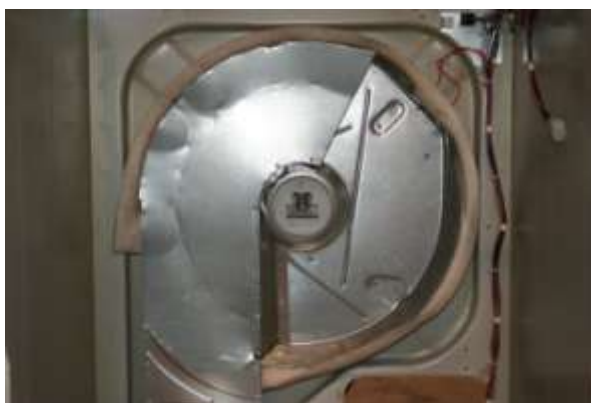
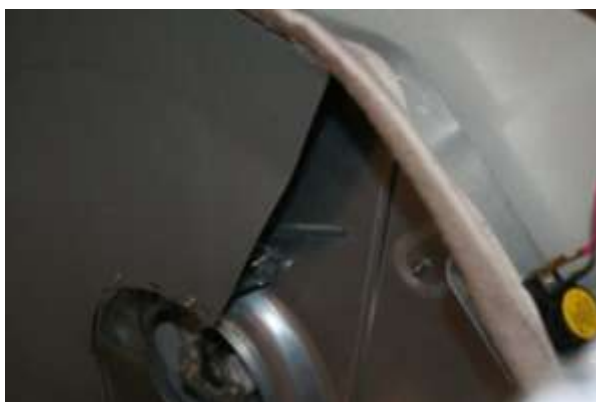
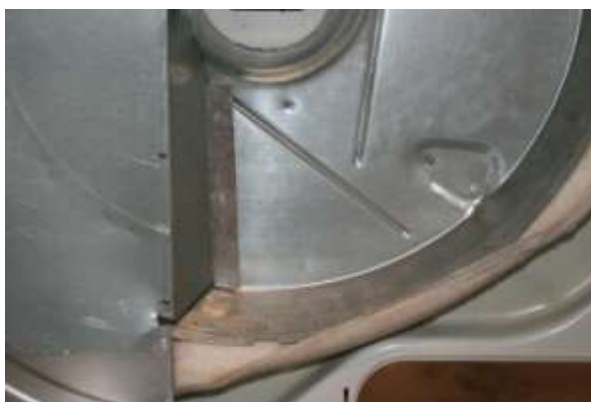
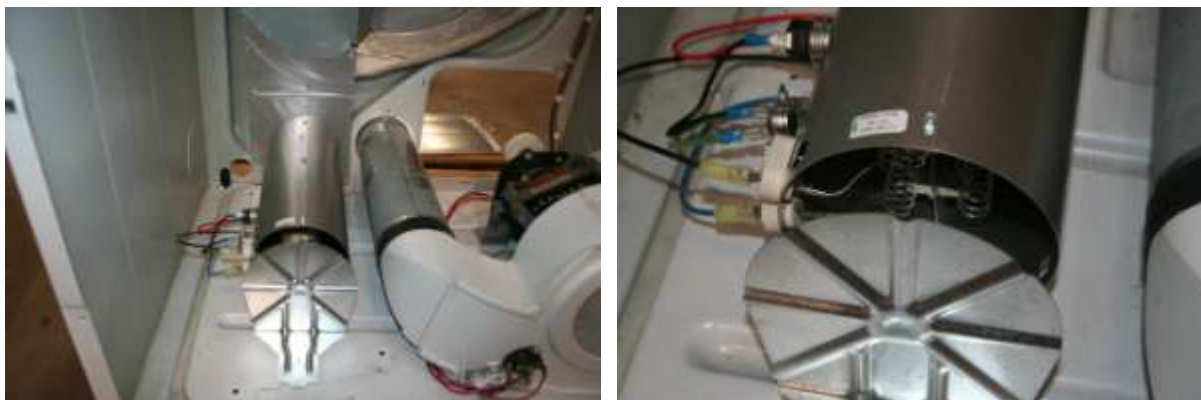
Below are photographs of the Wright Group's alternative design for the Electrolux 5.7/5.8 Cu. Ft. electric dryers. The alternative design for the electric model has been operationally tested using a large towel load and was found to retain the same average drying time as an unmodified Electrolux electric dryer.

Wright Group's Alternative Design for 5.7/5.8 Cu. Ft. Electric Dryers

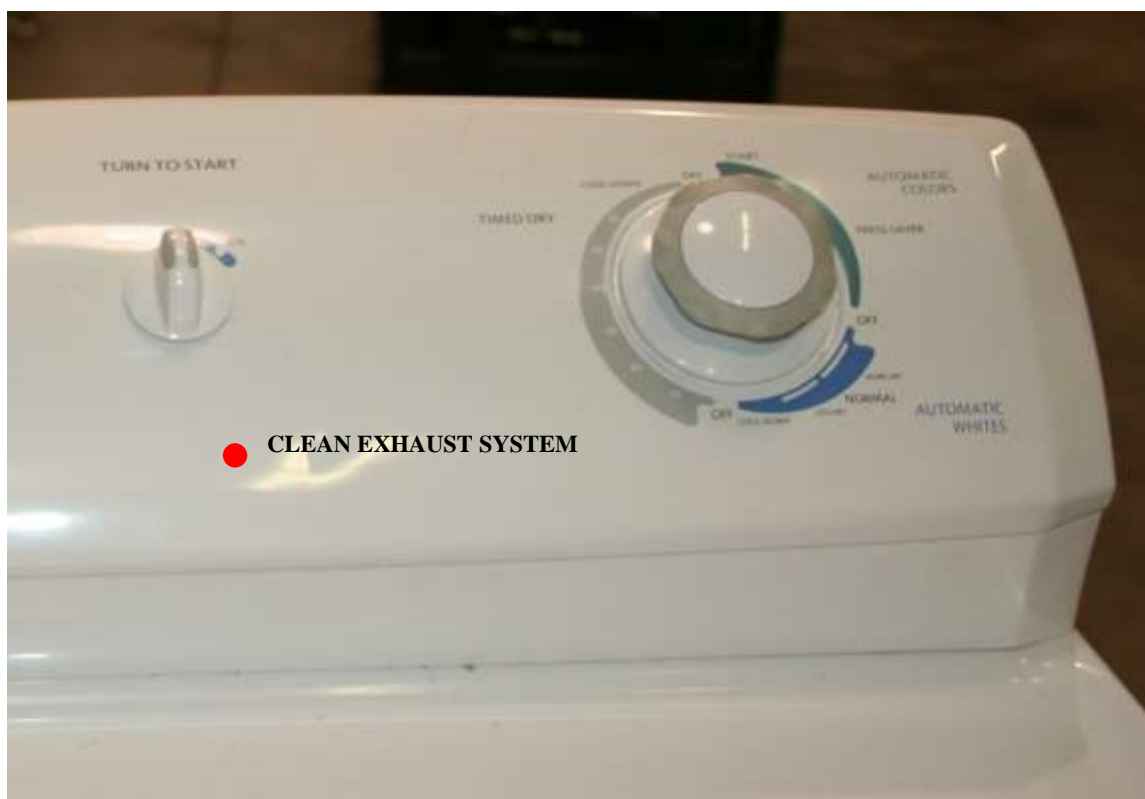
The Wright Group design concept uses a high limit monitoring system. The monitoring system would evaluate the high limit switch when the switch opens. The purpose would be to actively evaluate the efficiency of the external exhaust system, a variable that the dryer manufacturer has no control of but recognizes as a fire hazard if the vent is restricted and causes lint to accumulate within the dryer cabinet near the heat source. If the external exhaust was not installed correctly or becomes restricted, and the airflow is not sufficient to properly exhaust lint from the dryer, the high limit switch will open. First, the switch will open and de-energize the heating element or gas burner, thereby removing the risk of fire, as the dryer will produce no heat. Secondly, an indicator light on the console will illuminate and instruct the user to "CHECK EXHAUST SYSTEM". Third an audible alarm will sound. Because this circuit is actively monitoring the temperature behind the drum, once the exhaust restriction is corrected, such as removing a blockage, the switch will close and normal operation will resume. This design would help reduce the accumulation of lint in dryers under circumstances where the exhaust system is deficient due to installation errors or lack of user maintenance.

Indicator Light for Exhaust Monitoring System

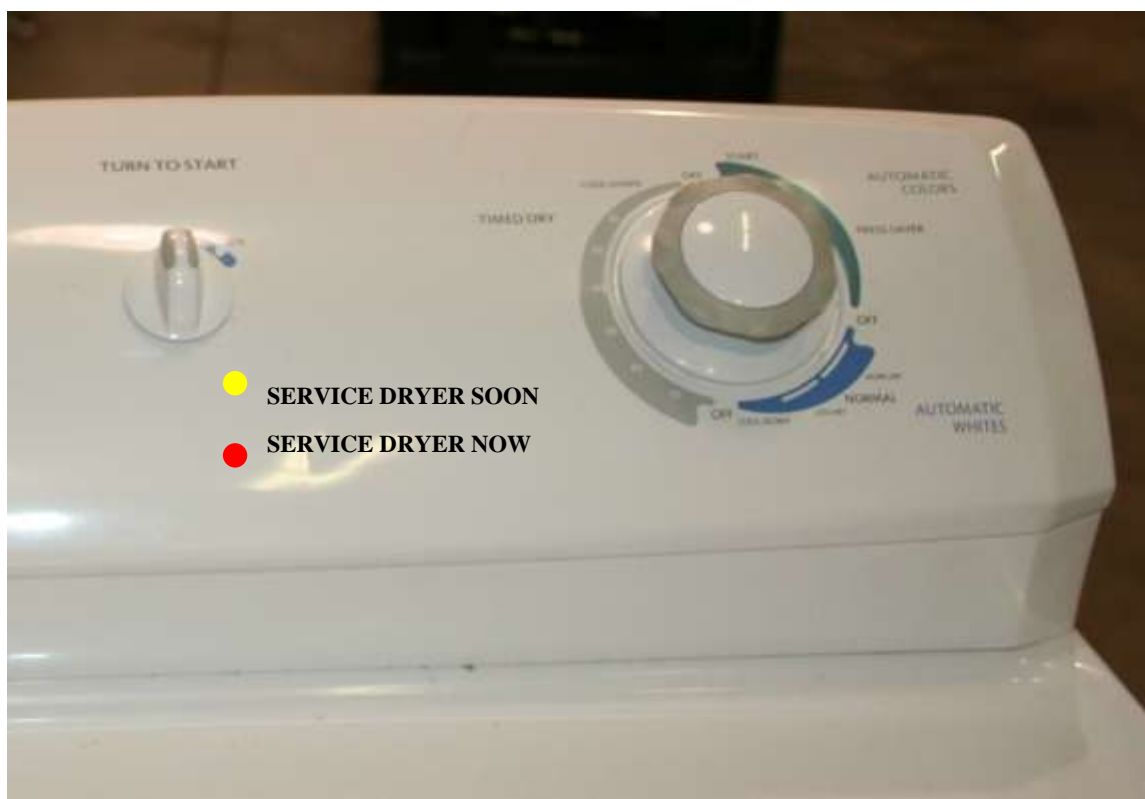
The Wright Group design concept uses a counter circuit, much like the odometer in every automobile manufactured for over 50 years. Applying this concept to the operation of the dryer, many different items could be monitored by the counter, for instance, the number of revolutions of the motor that rotates the drum and fan. The counter circuit would monitor the actual run time of the dryer and after the run time reaches a pre-determined value, as determined by the manufacturer, a yellow indicator light on the control console would illuminate and instruct the user to "SERVICE DRYER SOON". At this point the user has been warned that the need for service is recommended, but the dryer remains operational. If the user follows the warning and contacts an authorized service person to disassemble and clean the dryer, the service person would follow the instructions in the Service Manual and reset the counter circuit back to zero. If the user were to ignore the warning, the yellow light would stay illuminated as a constant reminder. When the dryer reaches a pre-determined fault tolerance, 125% for instance, the counter circuit will illuminate a red indicator light on the control console and instruct the user to "SERVICE DRYER NOW". As an additional safety device, the counter circuit would also open and de-energize the heating element or gas burner, thereby removing the risk of fire, as the dryer will produce no heat. The lack of heat will force the user have an authorized service person disassemble the dryer so that the counter can be reset, allowing the servicer to clean and inspect the interior of the machine.

Indicator Light for Periodic Maintenance Reminder

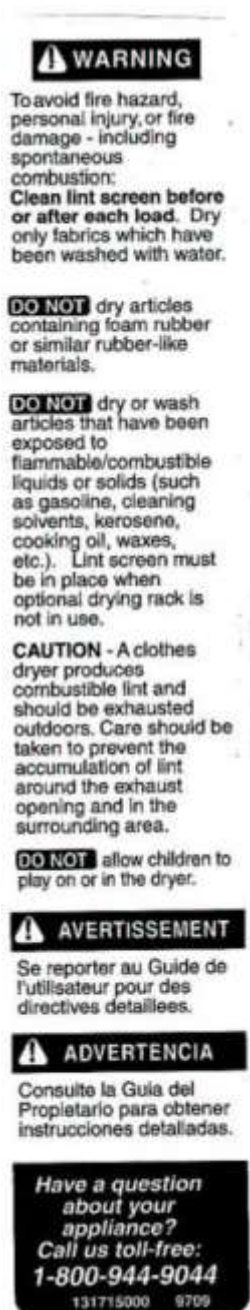
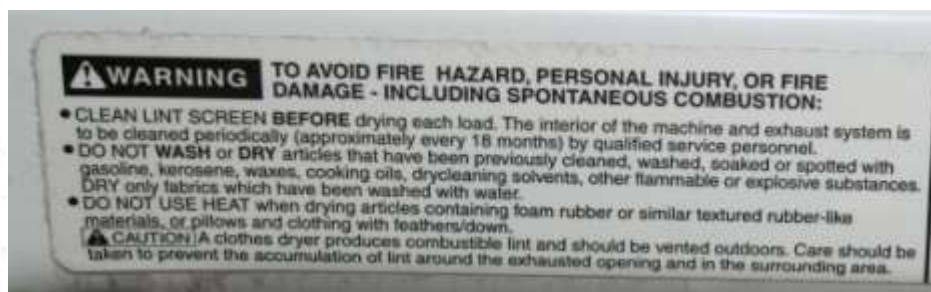
The warning label is installed on the right side of the drum opening and is visible to the user when the door is open. The warning on the dryer does not warn against the fire hazards associated with lint collecting behind the drum at the heat source. This warning label only instructs to “exhaust the dryer to the outdoors”, and to “prevent the accumulation of lint around the exhaust opening and in the surrounding area”. The only other maintenance instructions regarding the exhausting of the appliance and prevention of lint accumulations within the appliance on the warning labels or visible on any of the component parts is to “Clean lint screen before or after each load.” The Electrolux stand-alone dryers do not contain any warnings as to having the dryer serviced every 18 months, though their laundry centers, the combination washer/dryer unit, do have a warning label at the drum opening with those instructions. This

inconsistency demonstrates Electrolux's failure to provide consistent warning as to the maintenance methods they deem important as to the prevention of fires. Both labels are included below:

Warning Labels from Standalone Dryer (Left) & Laundry Center (Right)

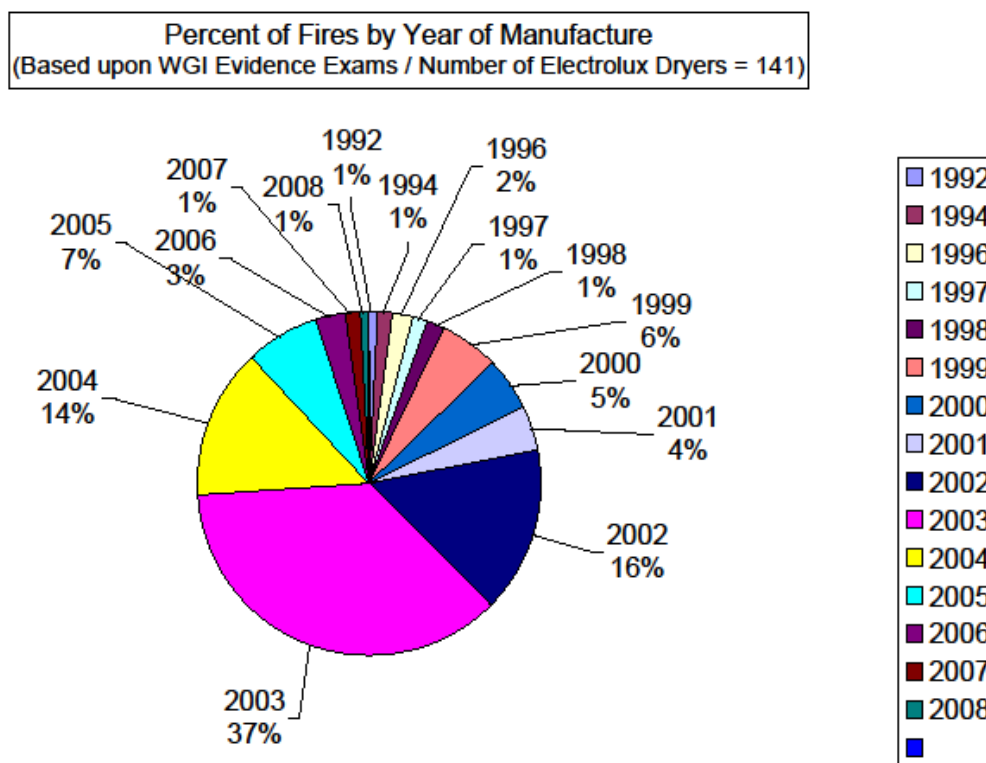
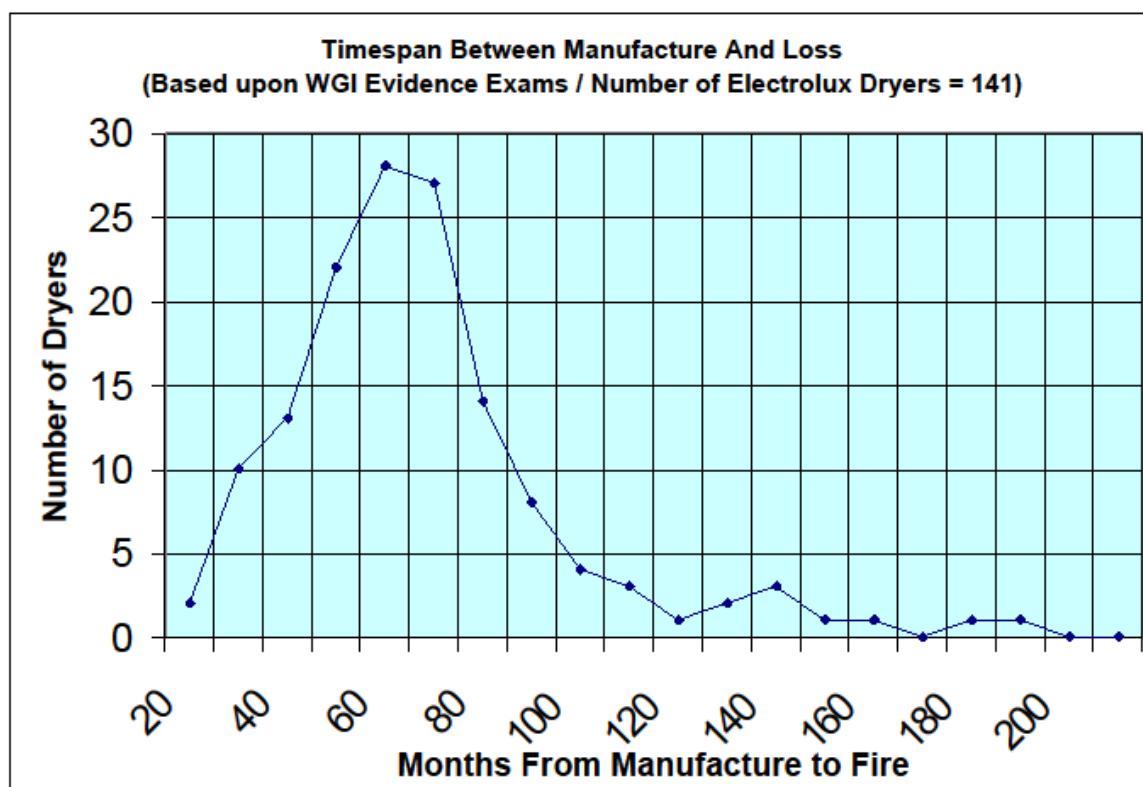
Statistical data was also compiled using these burned Electrolux dryers. For a group of 141 Electrolux dryers involved in fires (both gas and electric models), the following charts outline the percentage of fires based upon the year the dryer was manufactured and the time span, in months, between the date of manufacture and the date of the fire. The greatest frequency of fires occurred in a general range from 3 to 6.5 years, with the highest number of fires occurring approximately 5 years after the date the dryer was manufactured. The greatest percentage of dryers based upon the year of manufacture occurred after Electrolux altered the felt front seal. Similar statistical analysis has been conducted by some of our peers, including Fire Findings Investigations and the Traveler's Insurance Laboratories. Their findings were substantially similar to the Wright Group's statistical analysis.

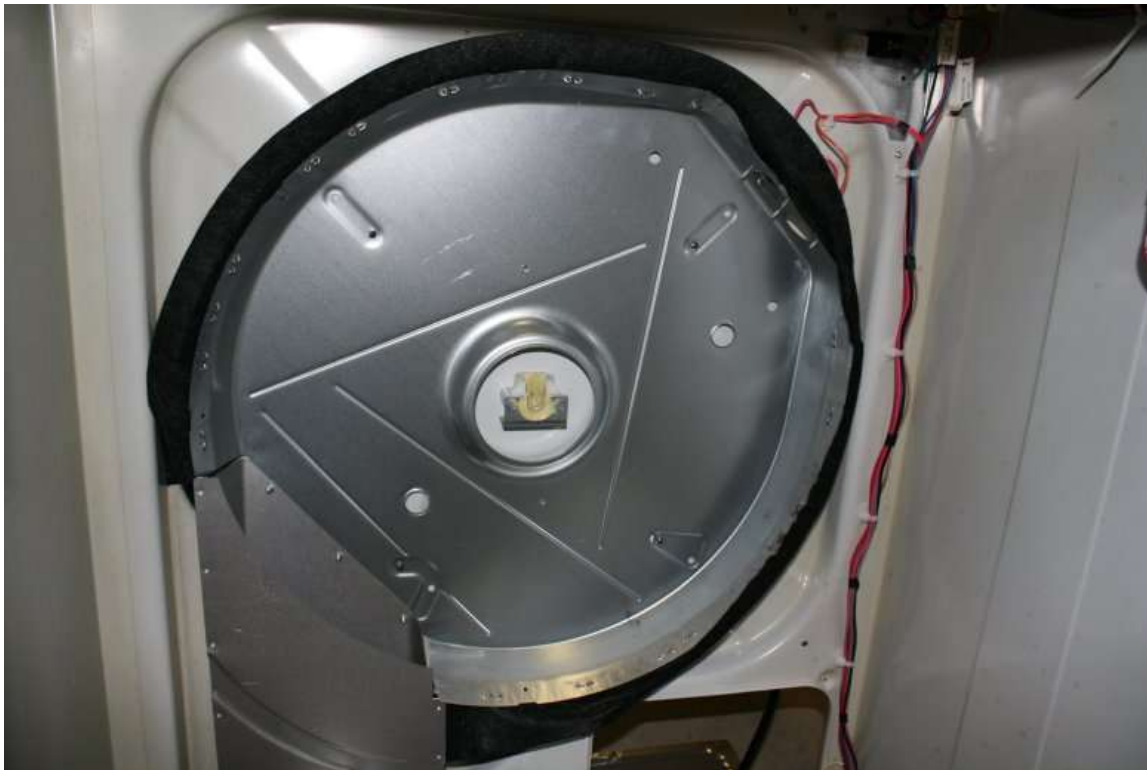
Photo 1: New Electrolux Dryer - Heater Pan before Testing

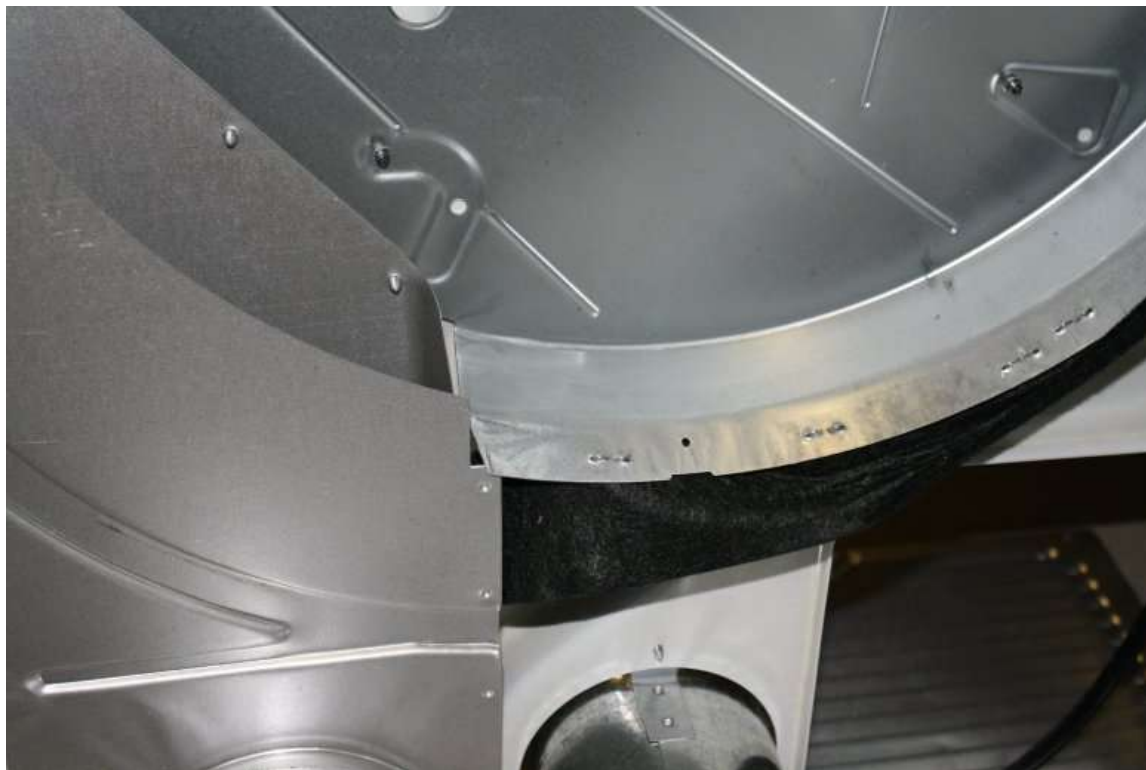
Photo 2: New Electrolux Dryer - Heater Pan before Testing

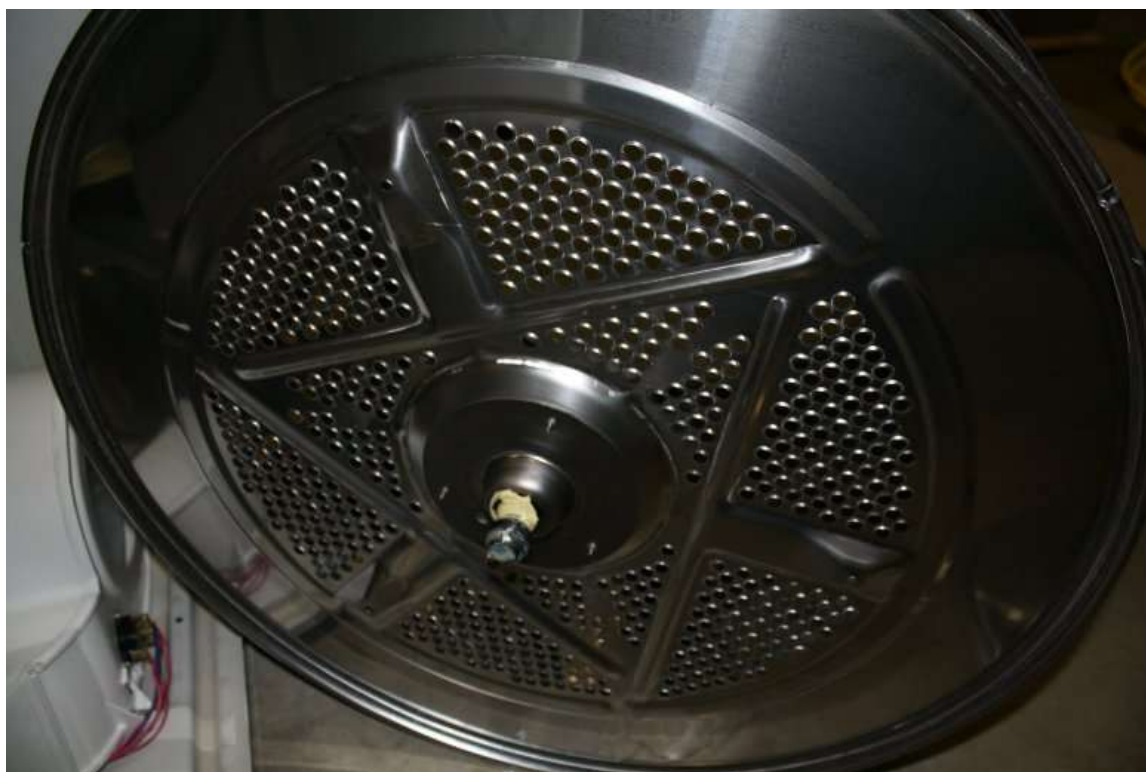
Photo 3: New Electrolux Dryer – Rear of Drum before Testing

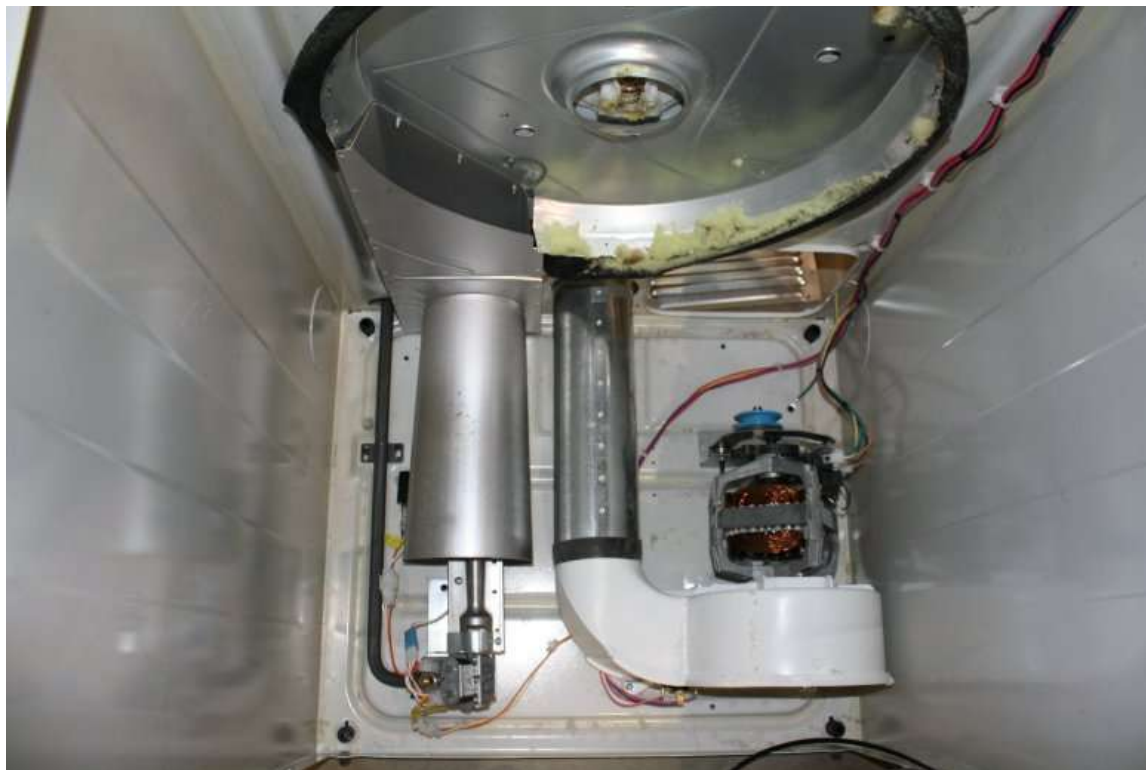
Photo 4: New Electrolux Dryer – Cabinet and Heater Pan after Testing

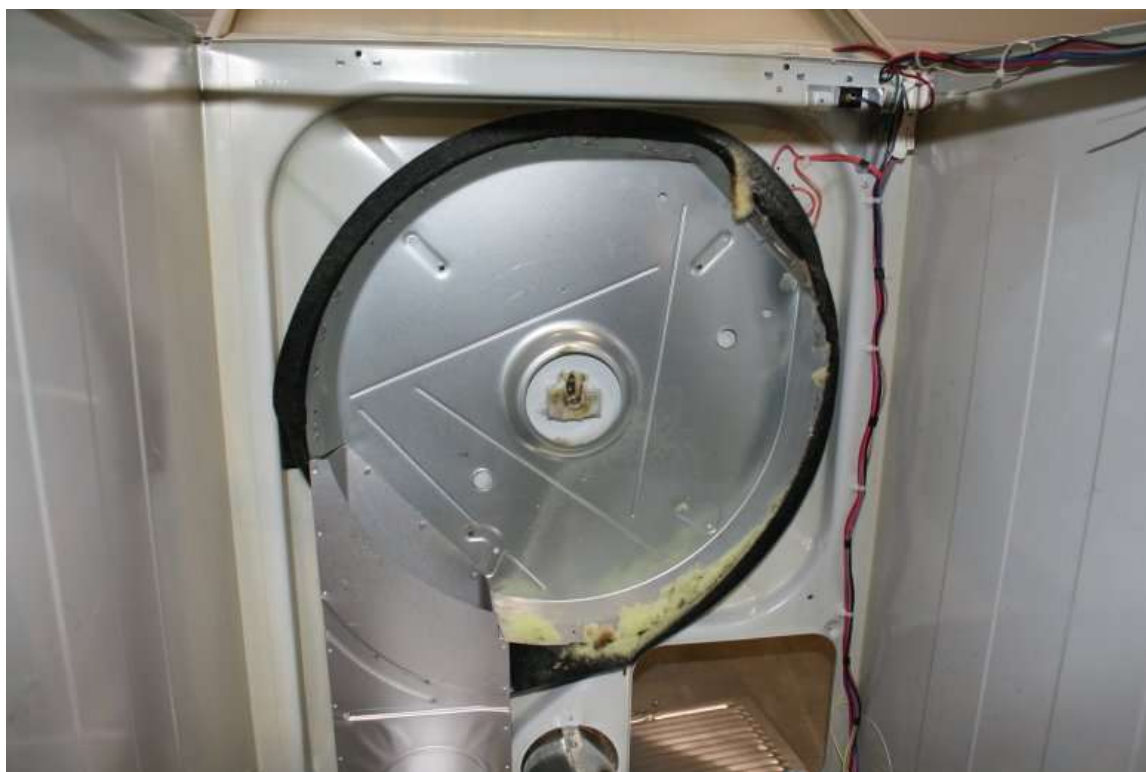
Photo 5: New Electrolux Dryer - Heater Pan after Testing

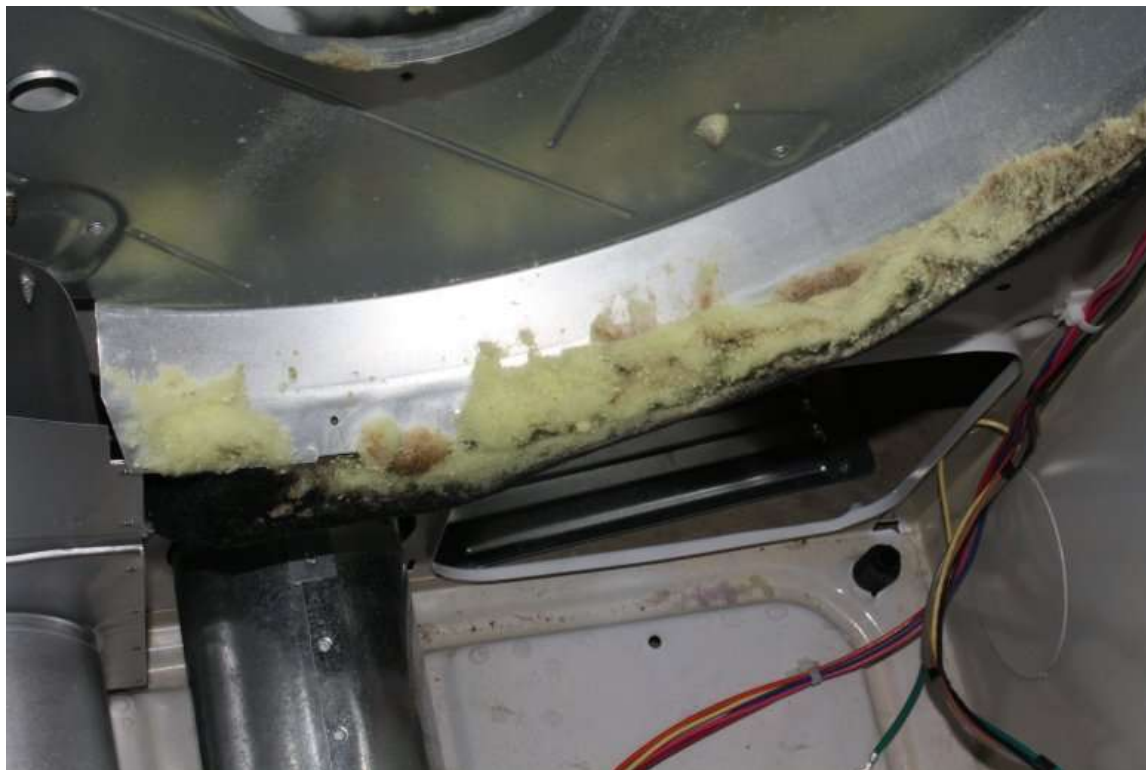
Photo 6: New Electrolux Dryer – Lint in Heater Pan after Testing

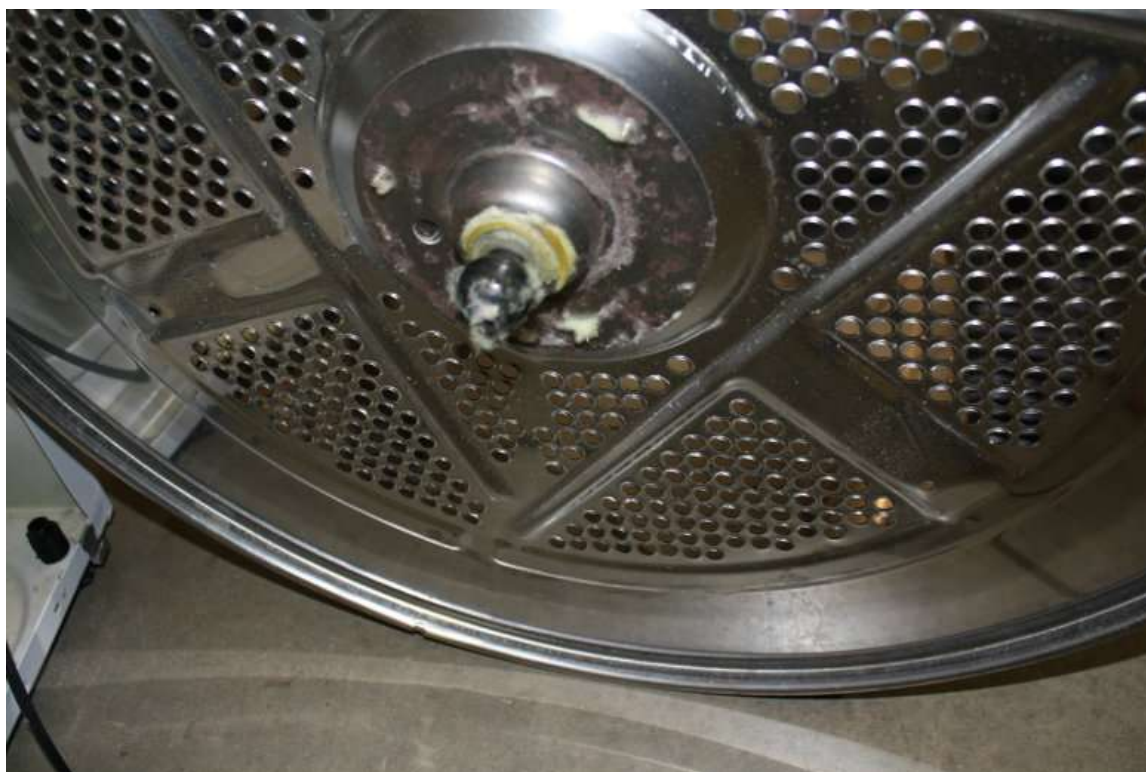
Photo 7: New Electrolux Dryer – Rear of Drum after Testing

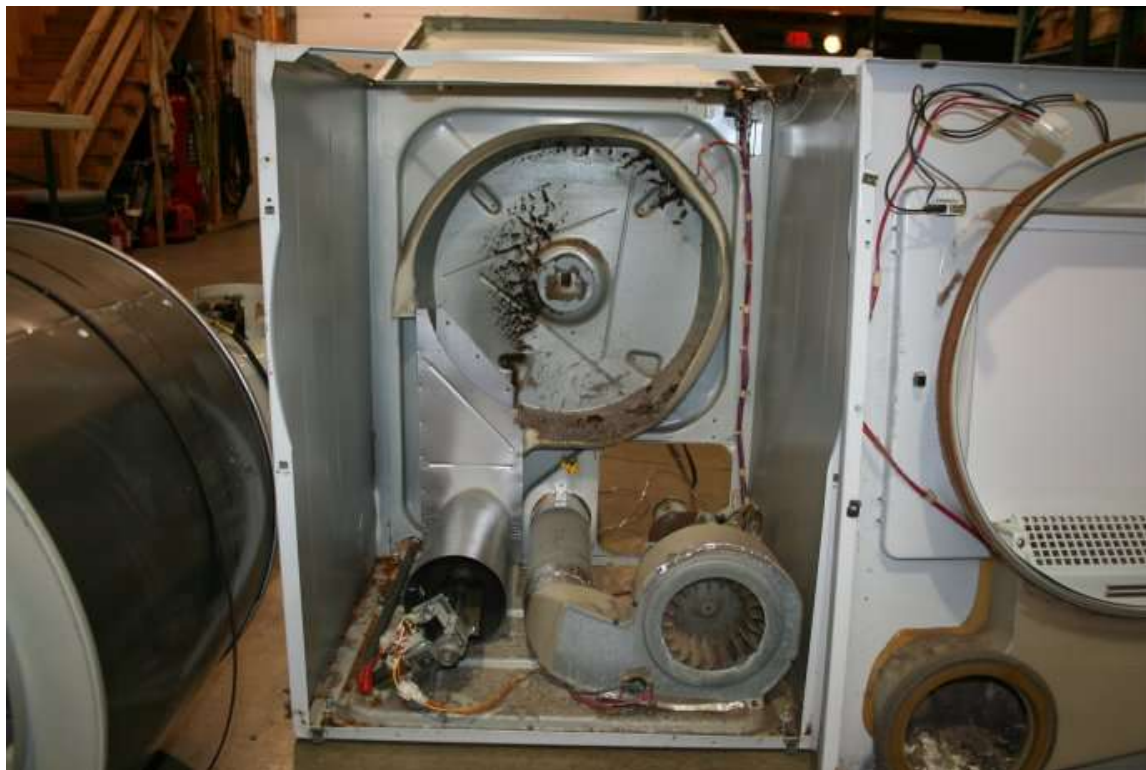
Photo 8: Used Electrolux Dryer - Cabinet before Testing

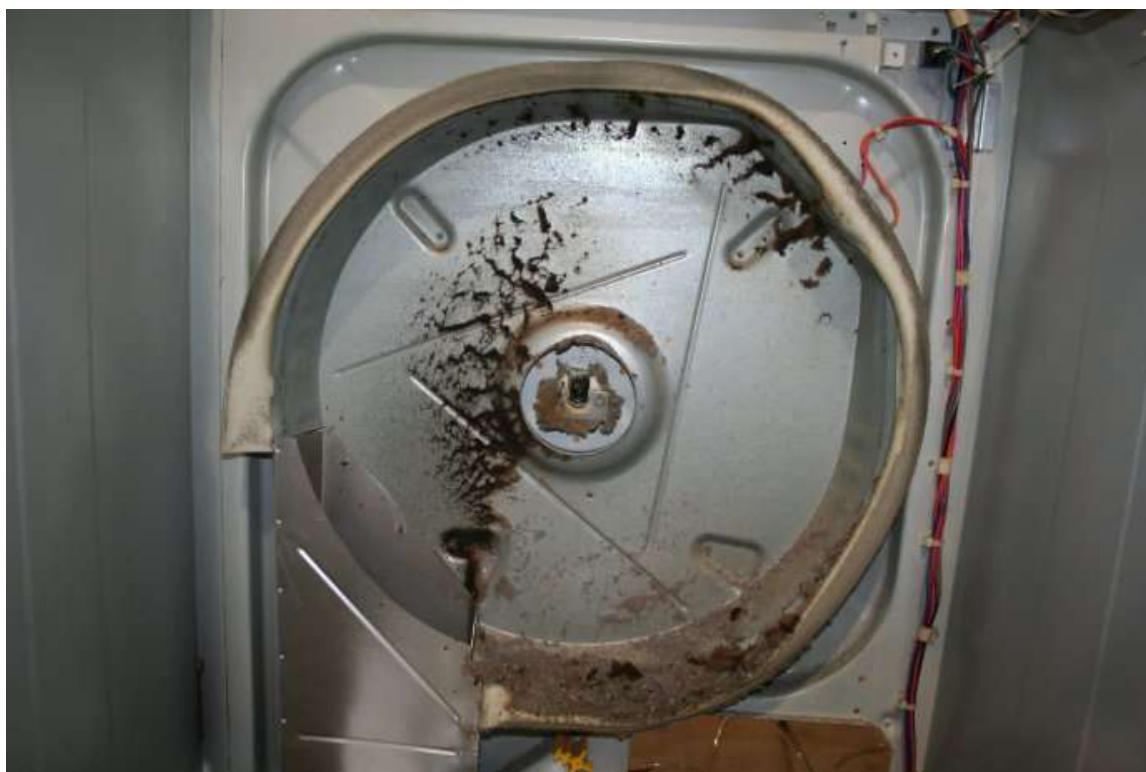
Photo 9: Used Electrolux Dryer – Heater Pan before Testing

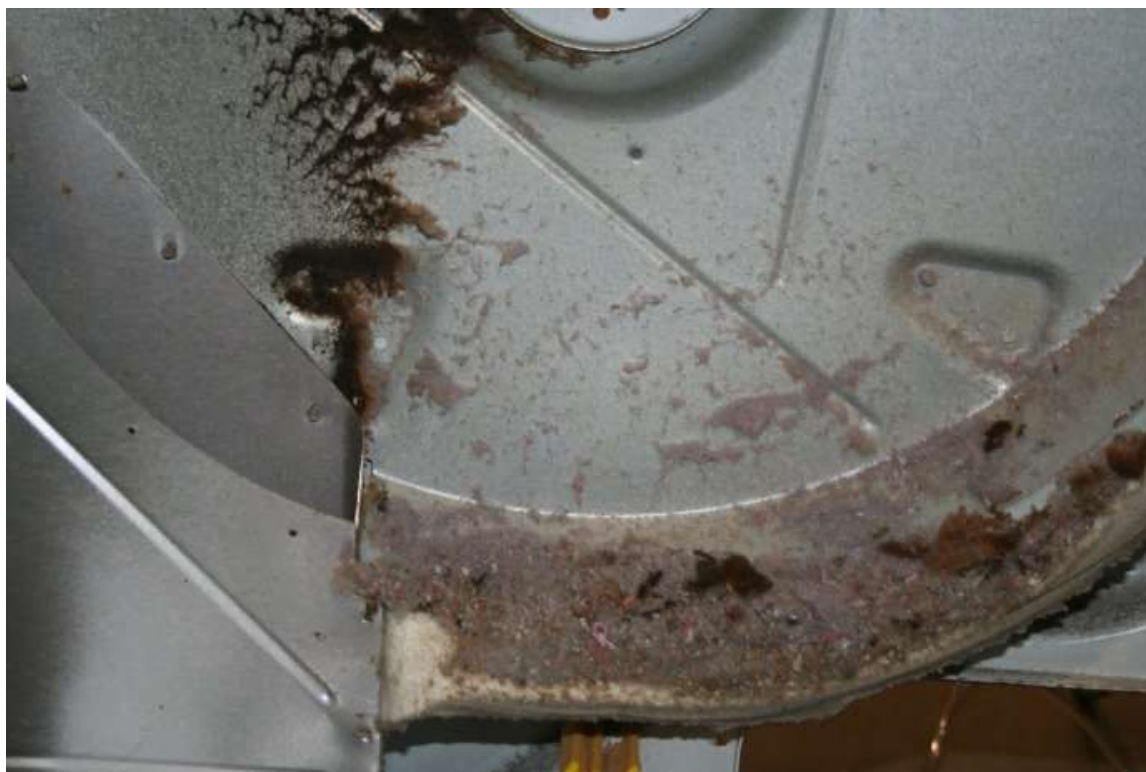
Photo 10: Used Electrolux Dryer – Lint in Heater Pan before Testing

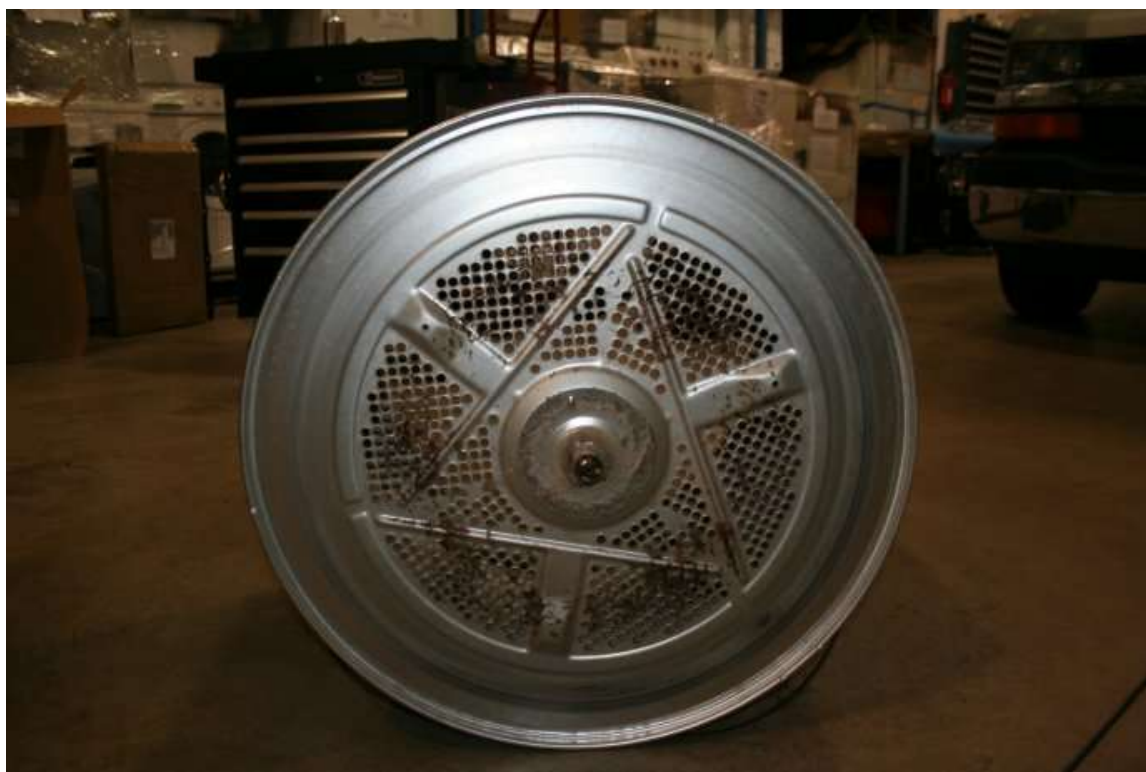
Photo 11: Used Electrolux Dryer – Rear of Drum before Testing

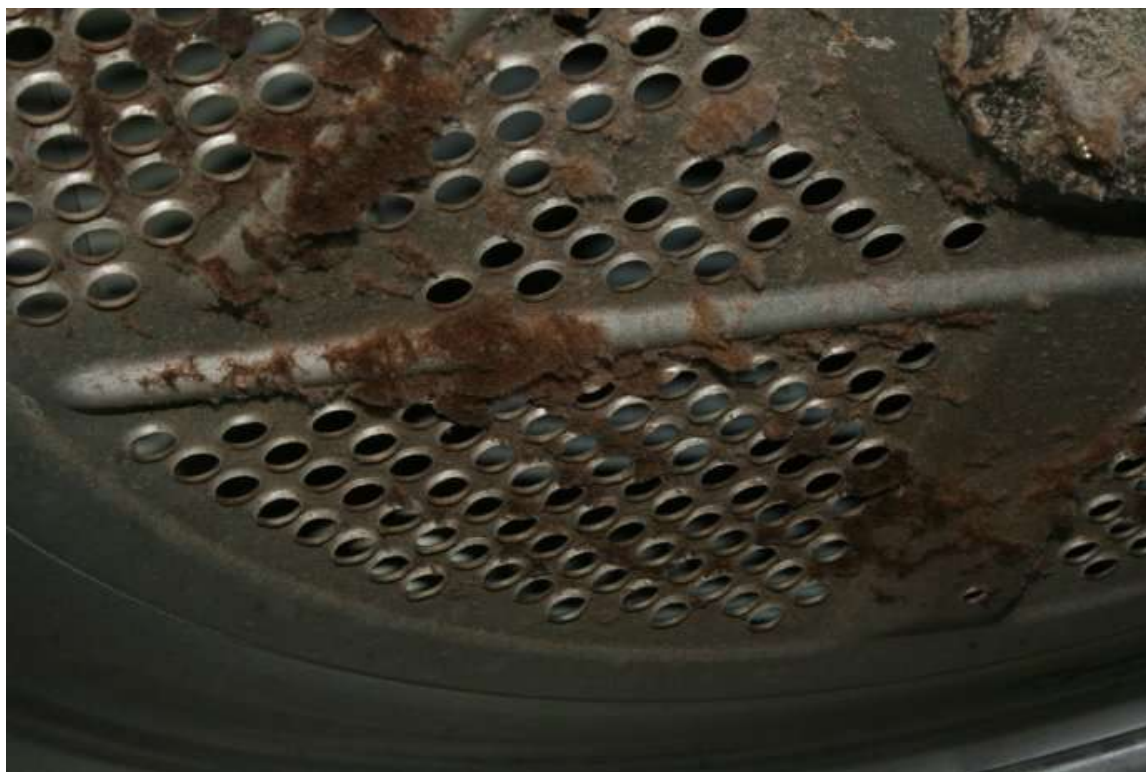
Photo 12: Used Electrolux Dryer – Lint on Rear of Drum before Testing

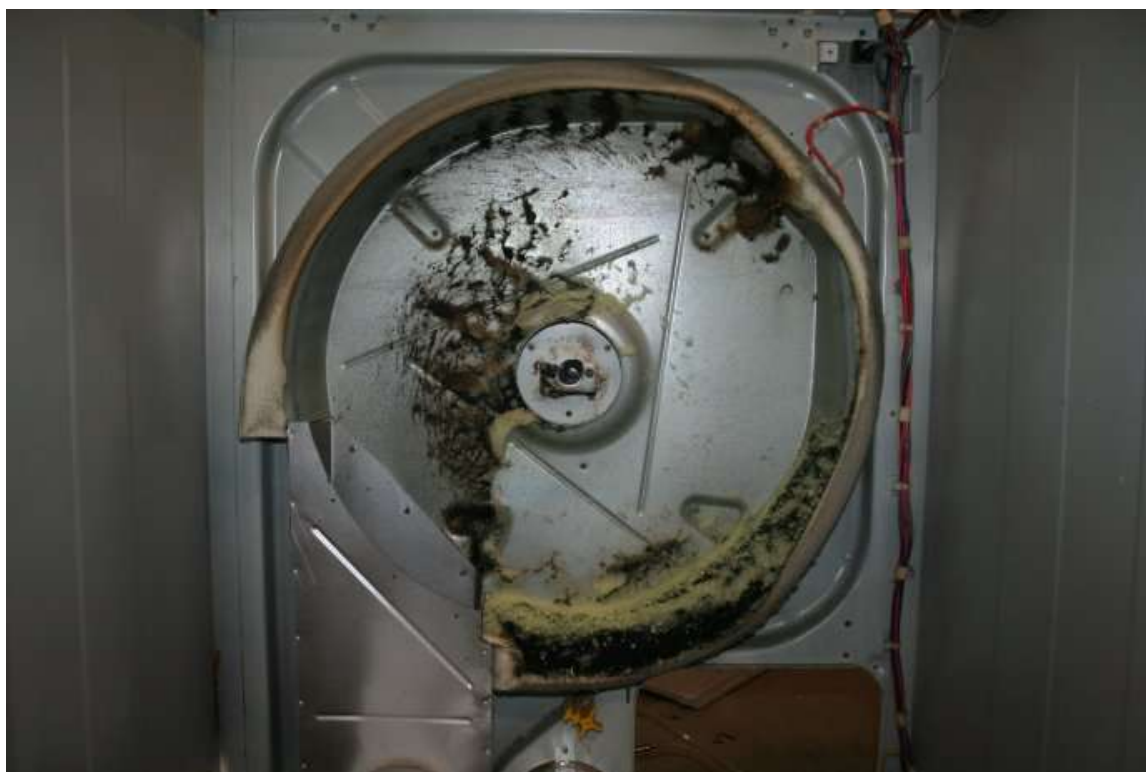
Photo 13: Used Electrolux Dryer – Heater Pan Testing

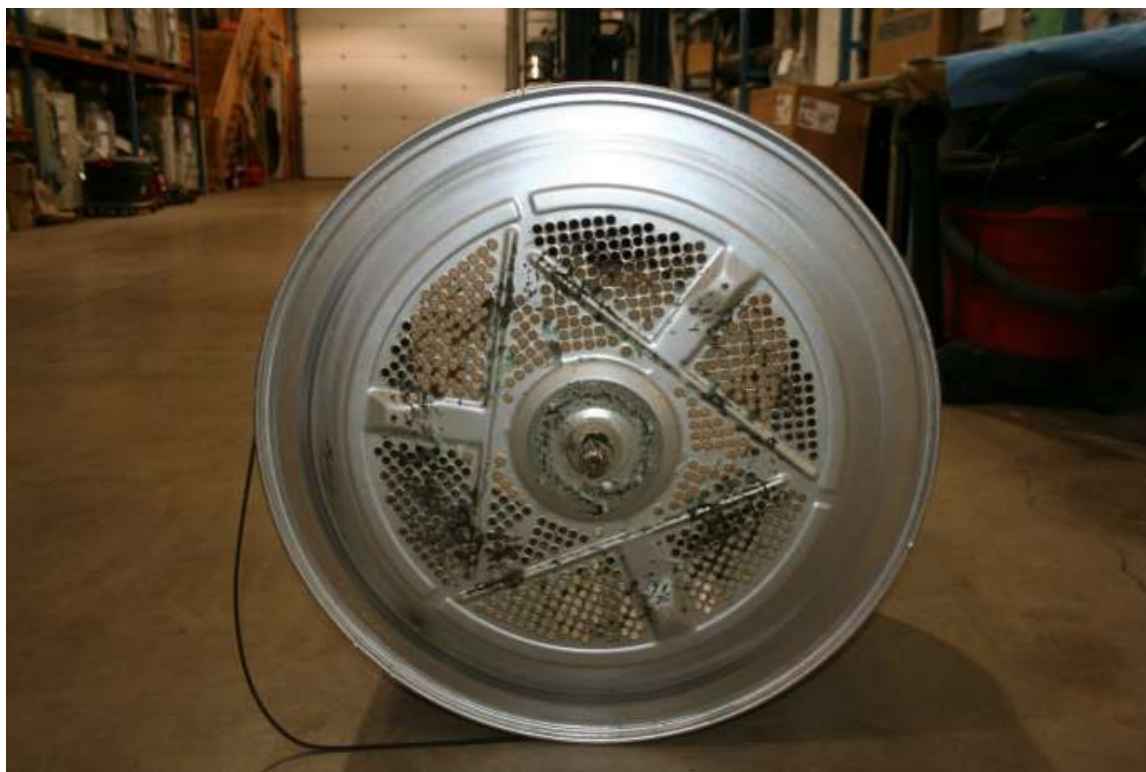
Photo 16: Used Electrolux Dryer – Rear of Drum after Testing

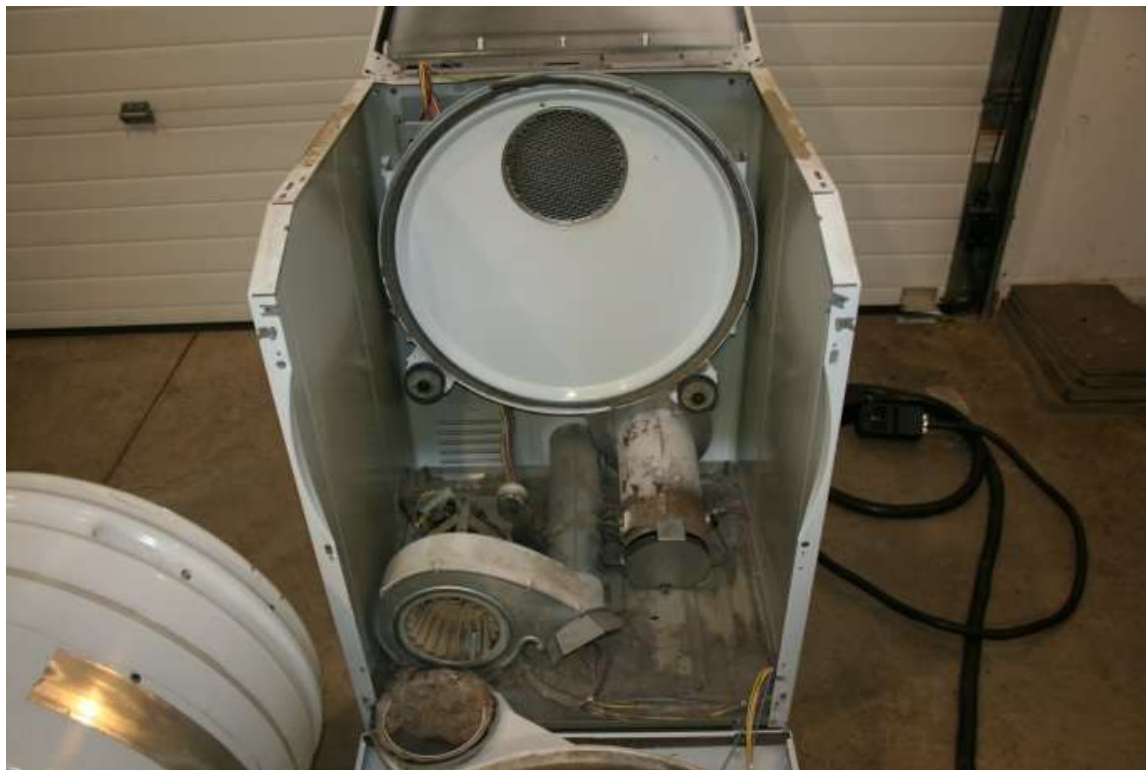
Photo 18: Used Maytag Dryer - Cabinet before Testing

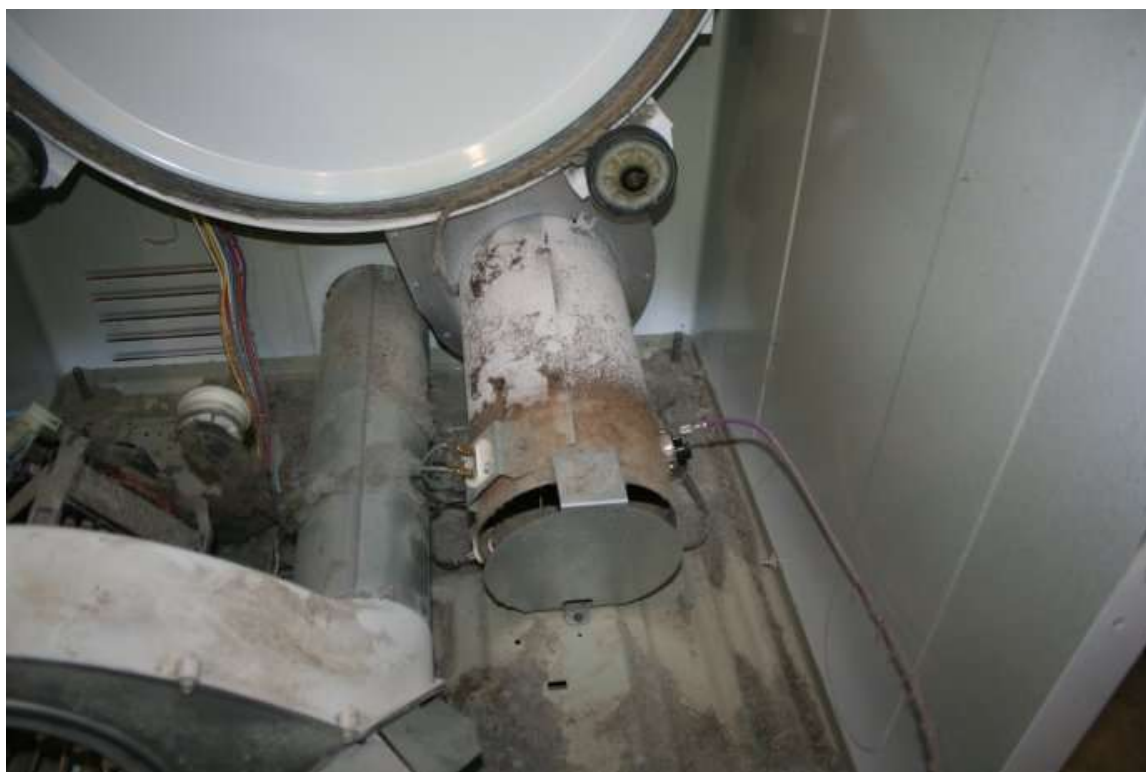
Photo 19: Used Maytag Dryer – Heater and Heat Duct before Testing

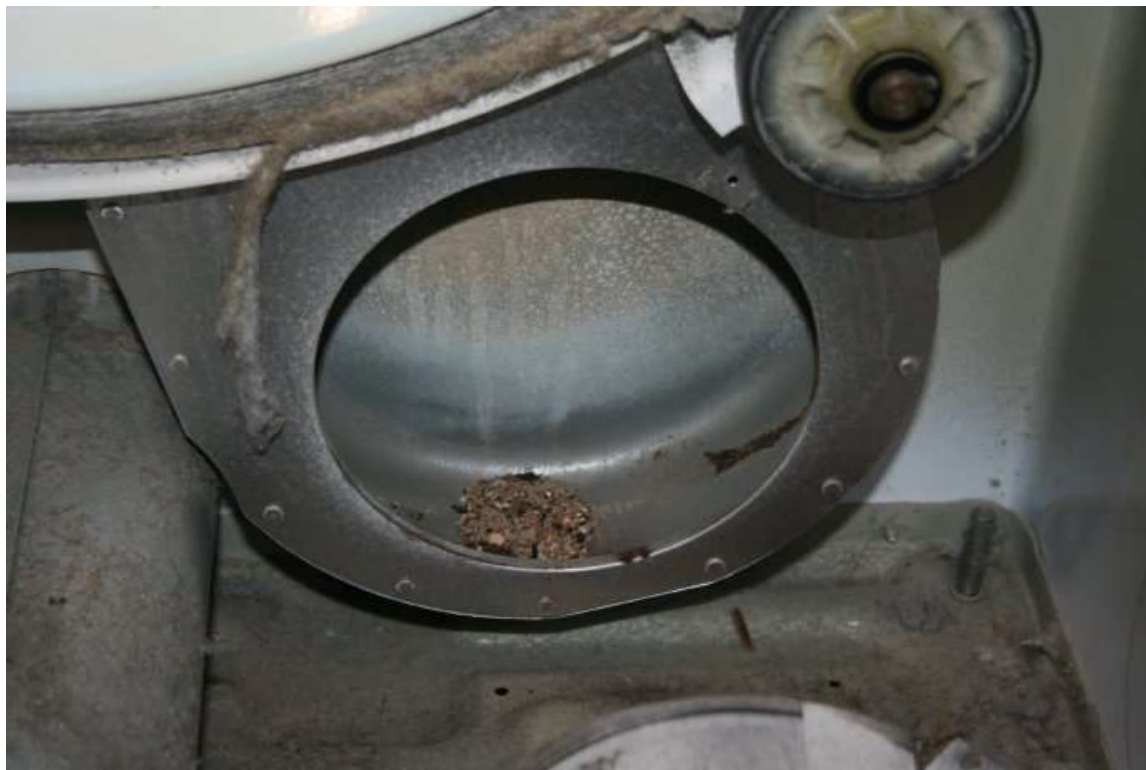
Photo 20: Used Maytag Dryer – Interior of Heat Duct before Testing
